Baseline Energy Performance and Opportunities to Improve Energy Efficiency in Family Military Housing

Washington State University Energy Program and Michael Blasnik and Associates

February 29, 2012

WSU Publication: WSUEEP12-005

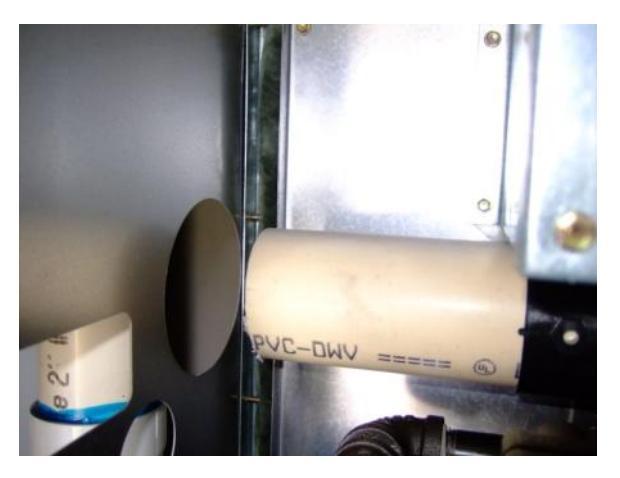
All space heating systems for homes in this study have been recently upgraded to high efficiency natural gas units; there is no recommendation for system replacement at this time. However, it is recommended that analysis of technologies and utility rates be conducted when these heating systems reach the end of their effective life. In the meantime, overall performance of both space heating and DHW systems can be increased by installing them within conditioned space. This could be achieved relatively easily in the New Hillside and Davis Hill developments by replacing the existing exterior mechanical room door with an R-5 insulated door, and assuring that combustion air is plumbed directly to the sealed combustion furnace from the outside (see Figure 8a and 8b.)

Figure 8b. Combustion supply air intake cut at furnace cabinet.

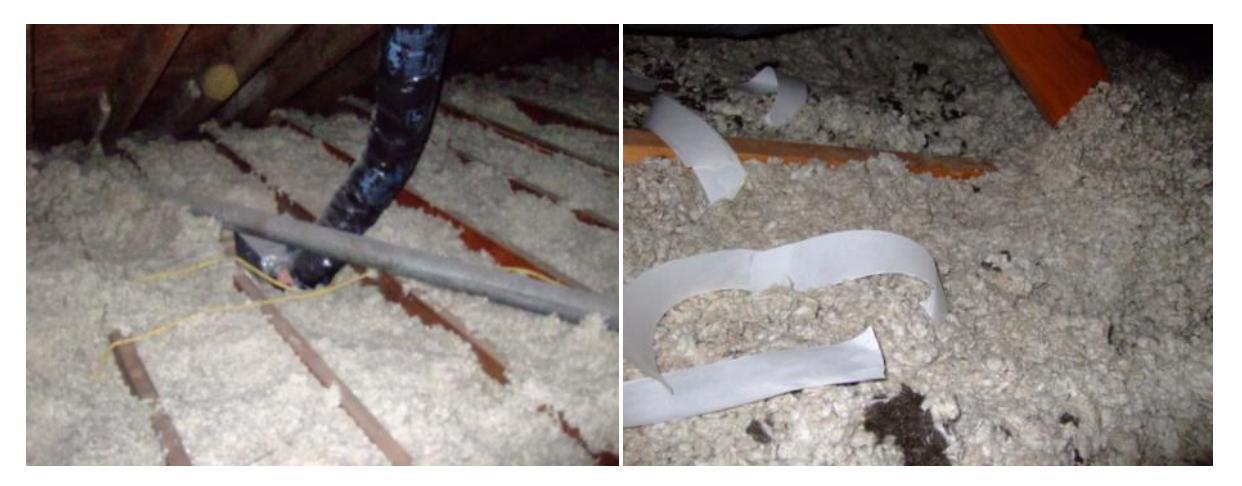
In general, most homes had minimal attic insulation, at or about R-15. The insulation that was present was typically in poor condition with large areas of compression and incomplete and uneven coverage (See Figure 9).

Figure 9. Attic insulation in two different plan types showing compressed and inconsistent fill

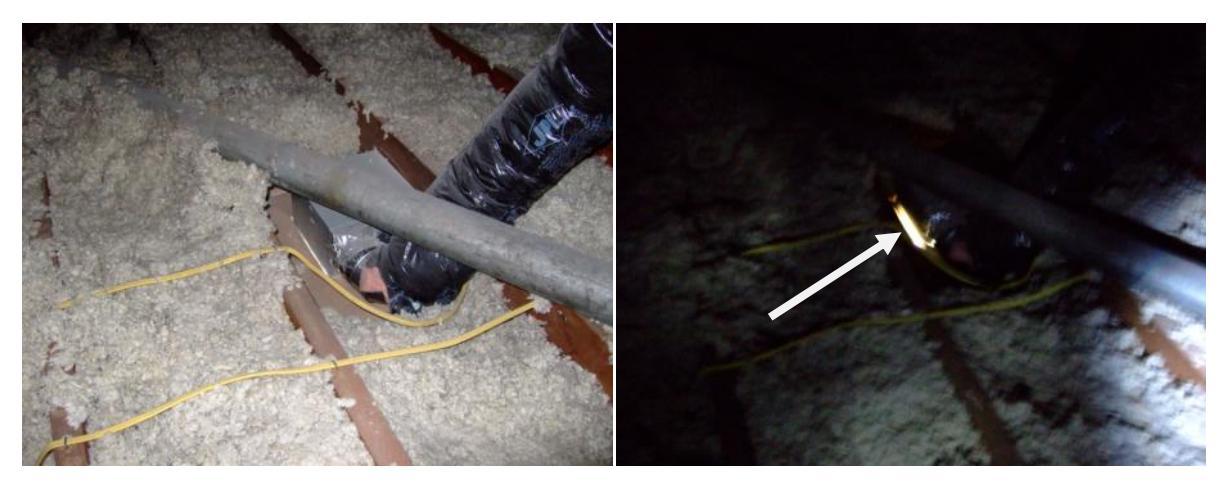
Ceilings were also found to be have compromised air barriers with poor or no air sealing around penetrations such as bathroom exhaust fans. (See Figure 10 – note light from bathroom below showing gap between sheetrock and fan [see arrow].) The only exceptions are the homes in the Discovery Village/Miller Hill communities which are insulated to R-38 with intact air barriers.

Figure 10. Bathroom exhaust fan installation showing significantly compromised air and thermal barrier

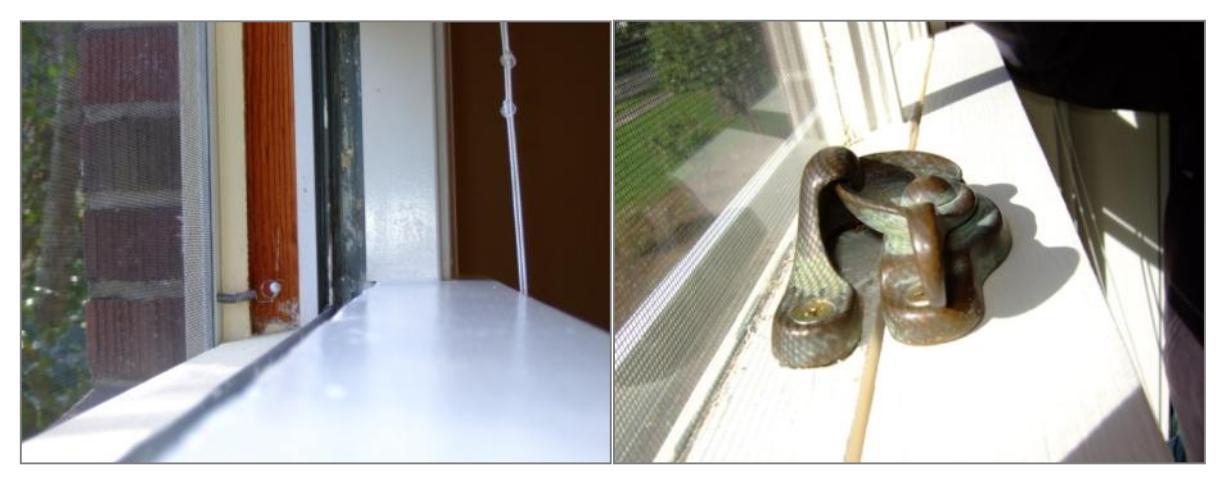
Windows in all developments but Evergreen and Broadmoor were typically multi-paned and vinyl framed. Evergreen and the newer homes in the Broadmoor development had aluminum framed double paned windows; a few had site-built ¼" double paned stopped in insulated glass units as fixed picture windows. The majority of the windows in the historic Broadmoor homes were original wood sash double hung single pane units; during renovation, the windows were repainted, but no additional air sealing was completed; testing found significant air leakage at all sash rails. A few double paned vinyl windows were installed in the non-historic portion of the structures.

Figure 13. Renovated single pane, double hung windows at historic Broadmoor home

At the next major renovation, all windows in homes of this study should be replaced with code compliant units (U-factors of .3 to .34.) Single pane glass in historic structures can be replaced by double-pane low-e glazing in the original sash. In addition, windows in the historic structures

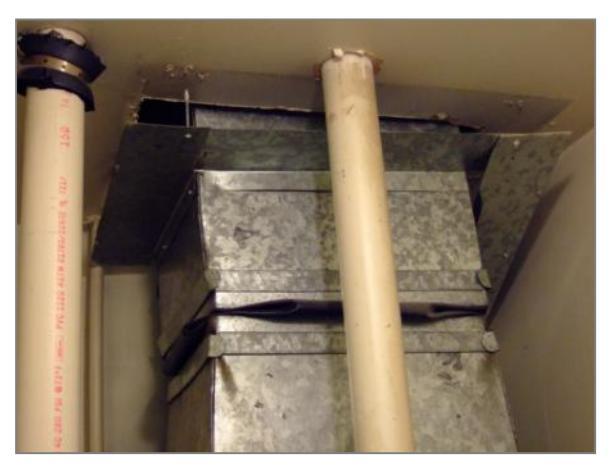
Figure 14b. Typical air barrier deficiencies

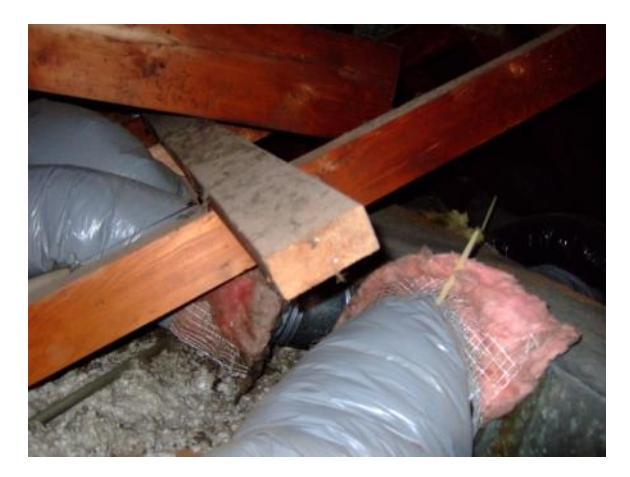
Homes at Evergreen, Beachwood, Davis Hill and New Hillside had supply ducts installed in the unconditioned attic space. Supply plenums were uninsulated and unsealed metal with insulated flex duct attached to supply plenums with varying degrees of sealing and mechanical fastening. Return duct work was typically a through wall plenum or flex jumper type duct into the mechanical closet from a hall way. Returns were uninsulated with varying degrees of air sealing.

Figure 15b. Disconnected flex supply duct

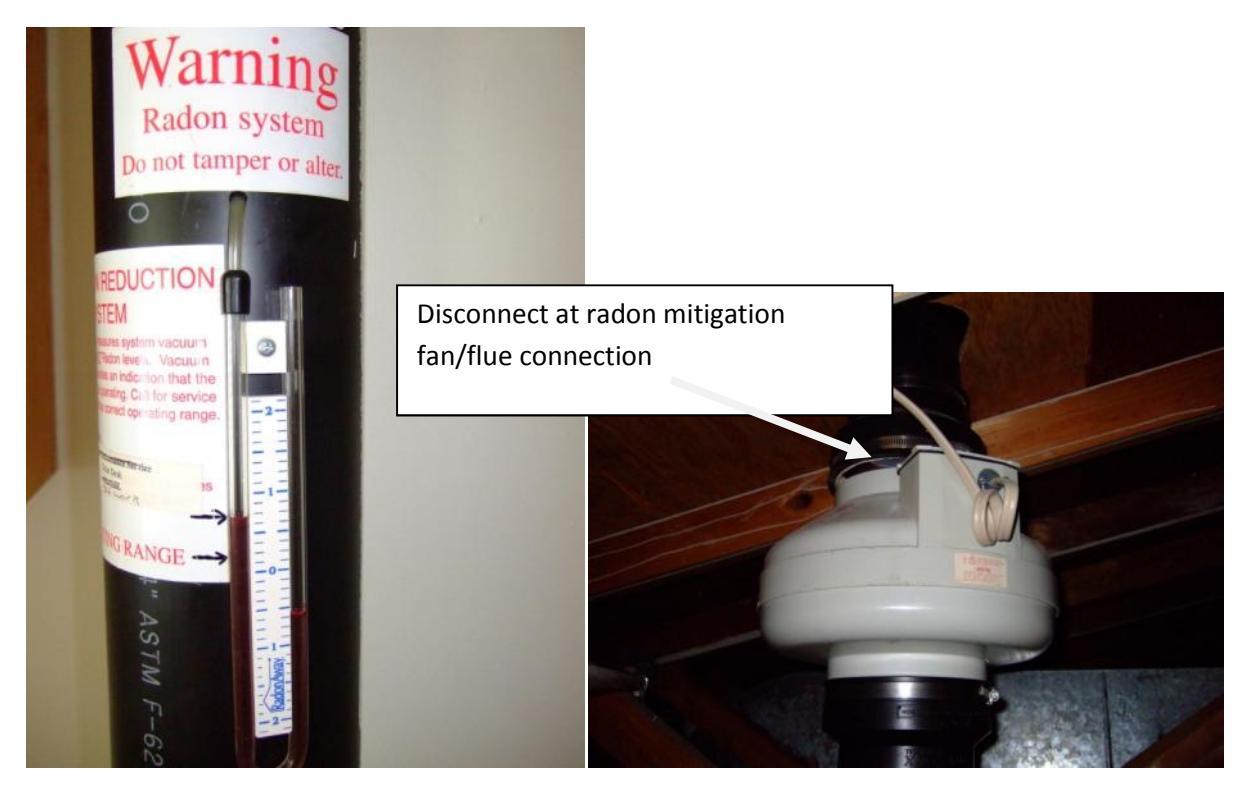
One of the randomly audited homes in the Beachwood development had a radon mitigation system installed. Little information regarding the details and age of this system was found. It was observed to be installed in the slab and designed to power vent to the outside through the roof. However the mechanical connection at the fan and vent flue in the attic had failed. It is not known if there are other homes on the base with elevated radon levels or radon mitigation systems. Reconnection of the exhaust flue to the inline fan should be performed on this system.

Figure 16. Radon mitigation system, Beachwood development

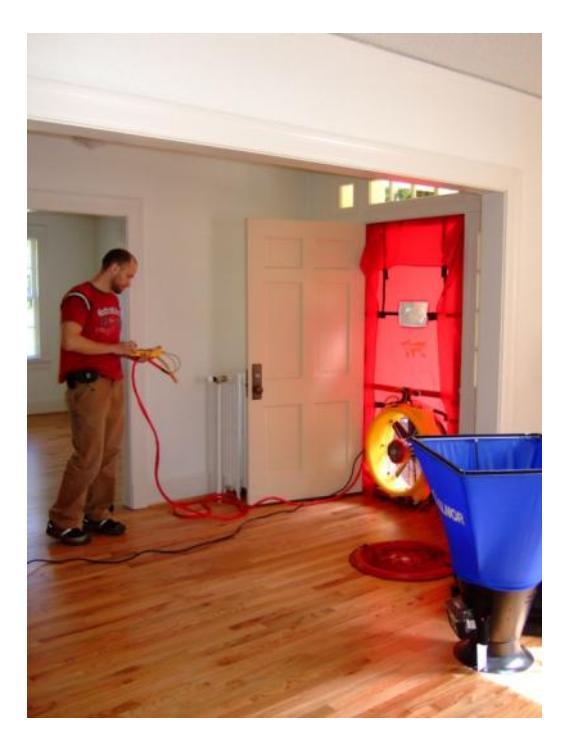
Substantial (largely interior) renovations had just been completed, but without any apparent air sealing measures

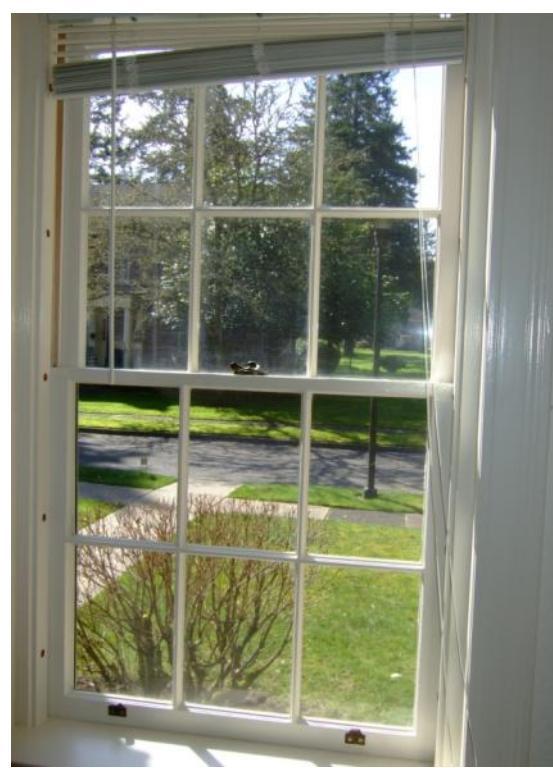
- Original double-hung, true divide light single-pane, wood framed windows.
- Windows had been restored, but sashes were not effectively sealed from air intrusion.

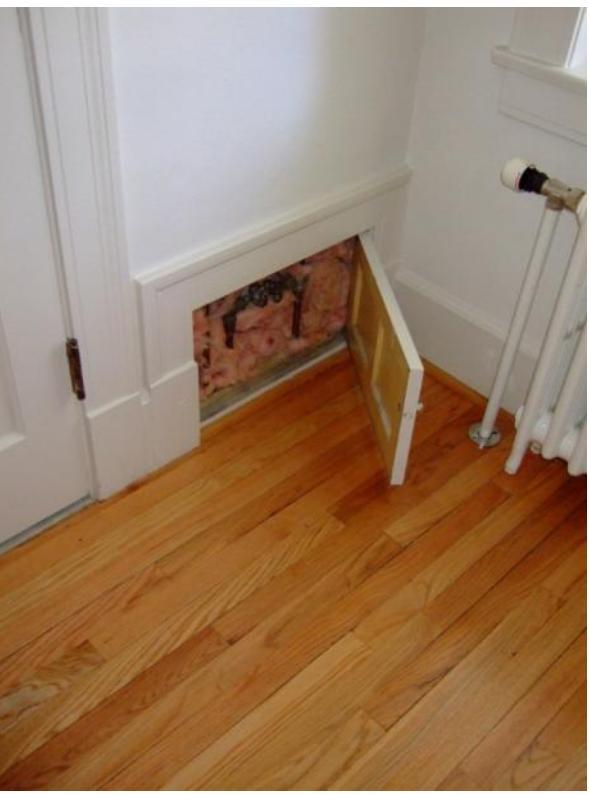
- Abandoned laundry chute
- Originates on the second floor and terminates in the unconditioned basement
- Cavity currently used for domestic water piping and filled with fiberglass insulation
- No air seal—is a major leak source

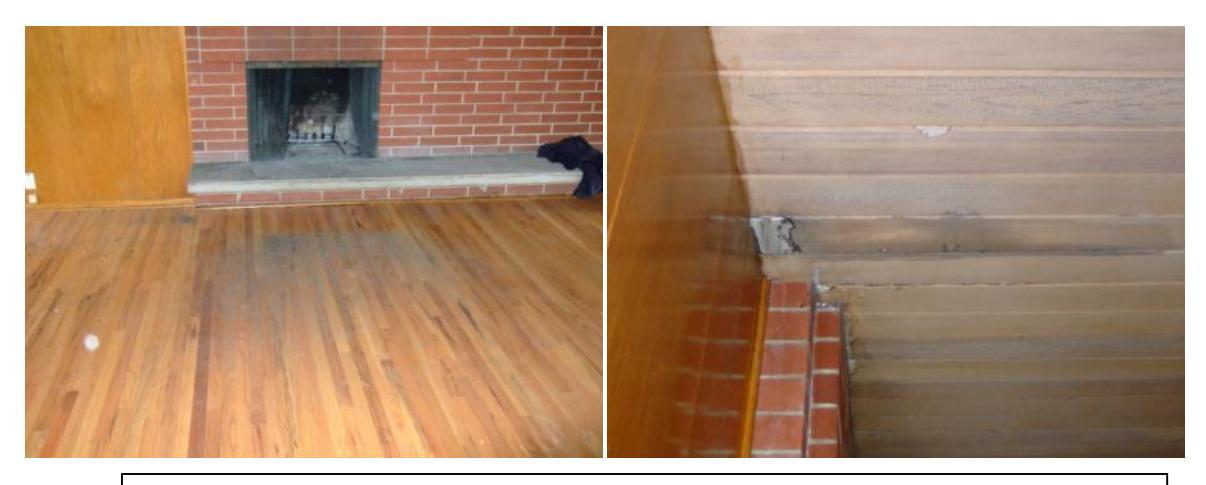
Fireplace flue without doors and penetration are significant air leaks

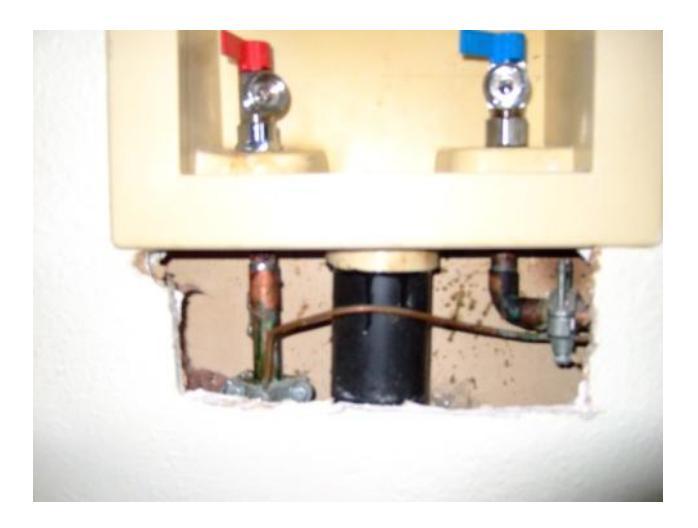
Plumbing penetration showing significant degradation to the homes air barrier

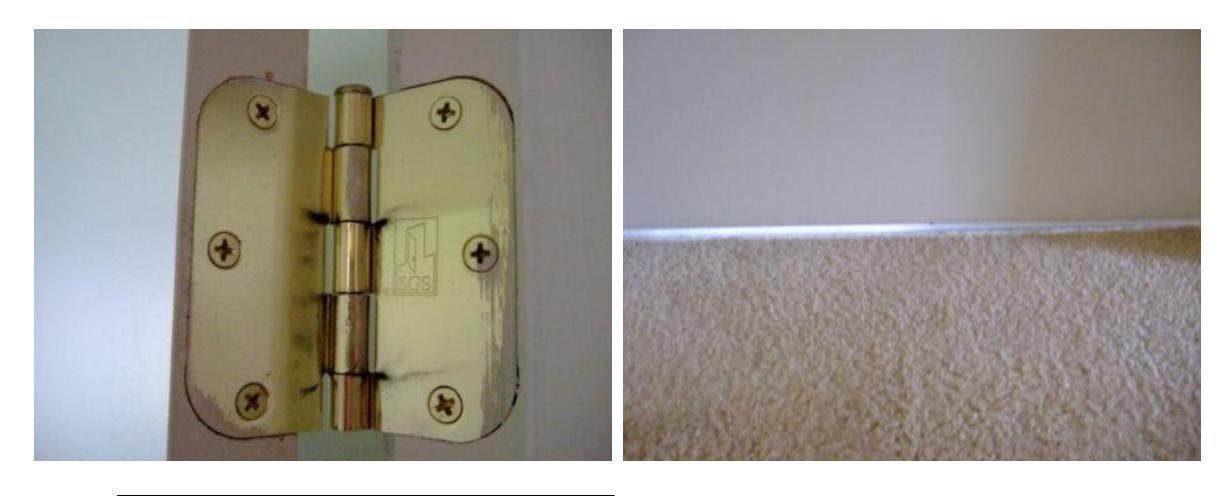
Bedroom door showing soot/dust staining

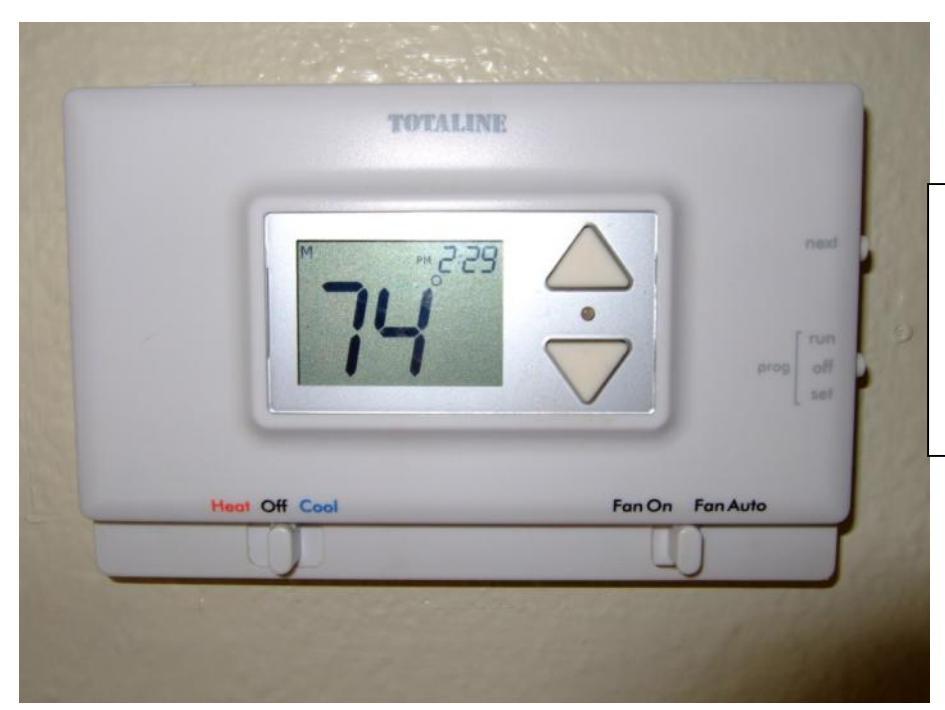
- Programmable thermostat used in many of the developments on JBLM
- The residents at 6855 New Hillside left thermostat in "Fan On" position most of the year
