Baseline Energy Performance and Opportunities to Improve Energy Efficiency in Family Military Housing

Washington State University Energy Program and Michael Blasnik and Associates

February 29, 2012

WSU Publication: WSUEEP12-005

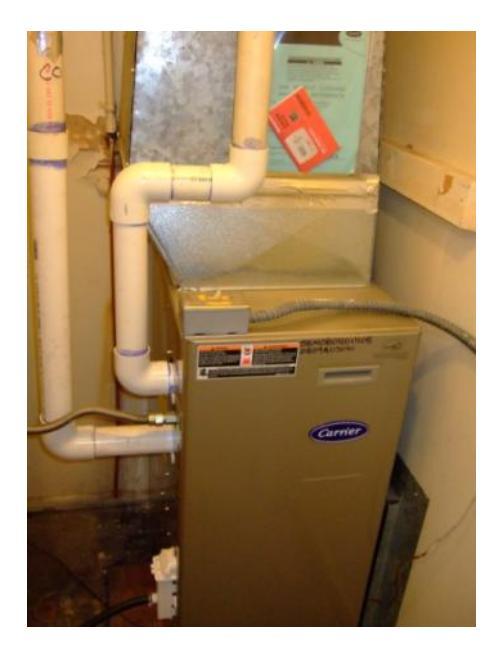
All homes audited had been retrofitted within the last 5 years with high efficiency (at or about an Annual Fuel Utilization Efficiency (AFUE) of .92) sealed combustion furnaces (see Figure 6a) except for the older Broadmoor development (which are currently phasing in .82 AFUE boilers (see Figure 6b), replacing boilers of unknown efficiency and performance that were in use during the billing periods analyzed in this study.) All of the furnaces were in operation prior to the start of the billing period analyzed in this study.

Figure 6a. Typical sealed combustion natural gas furnace

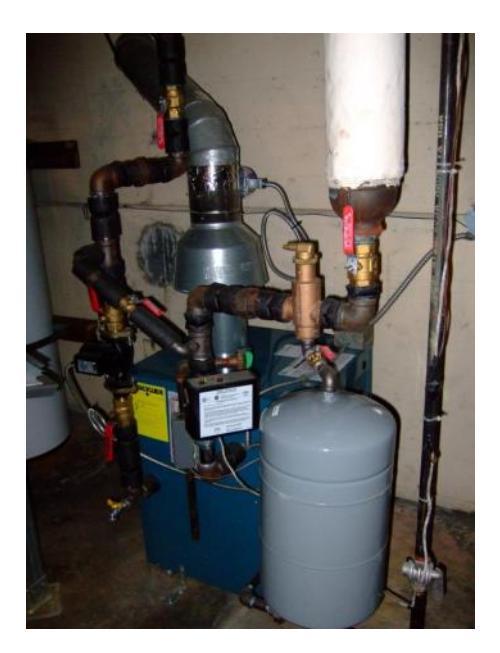
Figure 6b. Typical boiler found in recently renovated Broadmoor development.

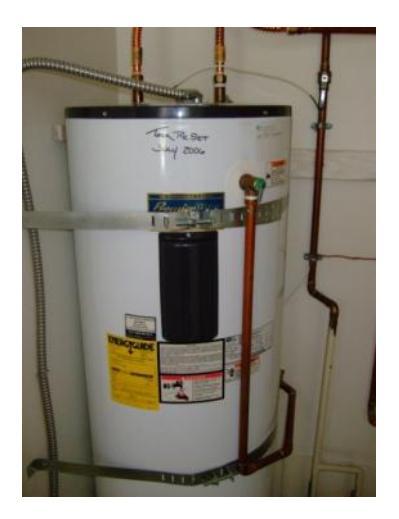
Figure 7a. Typical 0.90+ EF electric tank water heater

Development of a strategic plan for replacement of domestic hot water (DWH) equipment will ensure maximum cost-to-benefit when DHW equipment needs to be replaced again. Current models were placed into service relatively recently and are of higher than minimum efficiencies. However, higher efficient technologies are available, such as tankless natural gas and heat pump water heaters, and may be more cost effective than the models currently in use. In addition, fuel switching to natural gas may also prove to be an attractive option for homes where the furnace and DHW are installed in the same vicinity, and the service capacity allows the expanded use.

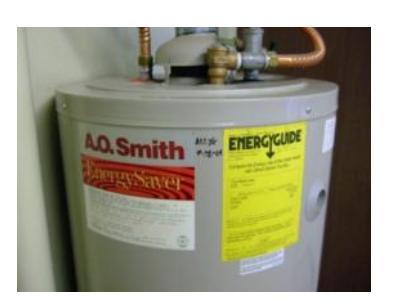
Figure 7b. Typical 0.60 – 0.62 EF natural gas tank water heater

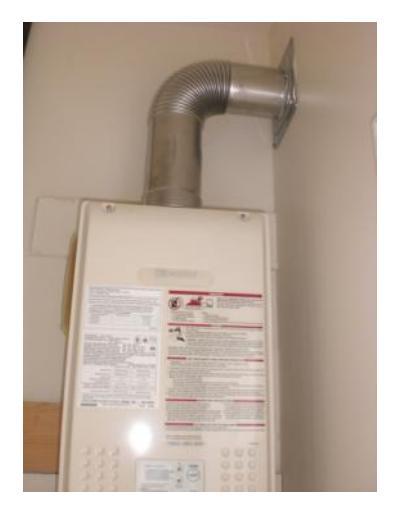
Figure 7c. Typical 0.82 EF natural gas tankless water heater found in Miller Hill homes

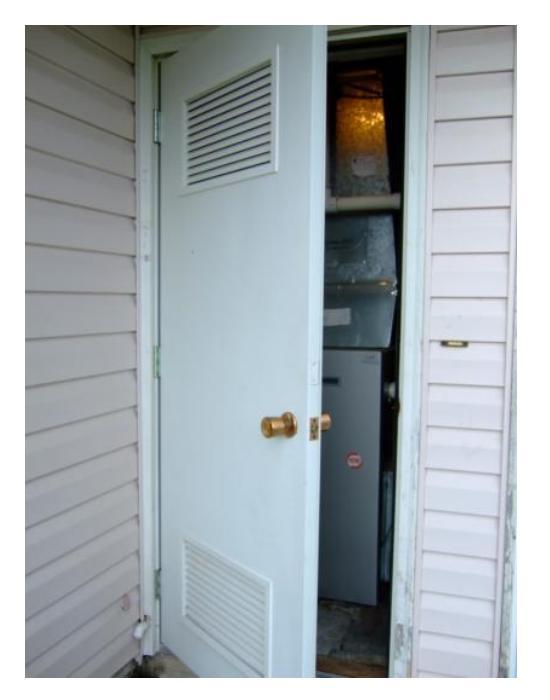
Figure 8a. Typical mechanical closet in Davis Hill and New Hillside developments.

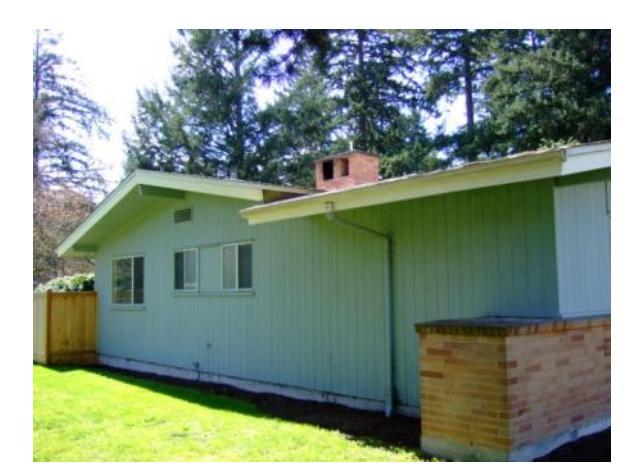
Figure 11a. Newer (1960s) Broadmoor home

It is strongly suggested that the homes in the Broadmoor development receive wall insulation when major interior renovation is done. This will most effectively be achieved by dense packing the walls from the interior in the historic Broadmoor homes. The 1960s vintage homes have a

mixture of brick and wood panel siding and would be easier to insulate from the exterior when major repainting or re-siding is planned for those homes.

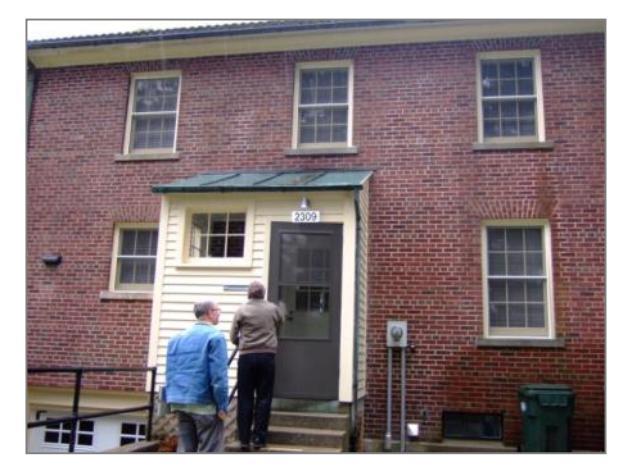
Figure 11b. Historic (1930s) Broadmoor home

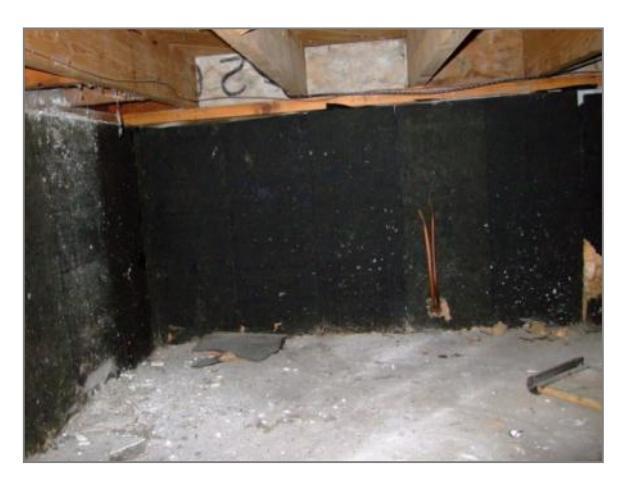
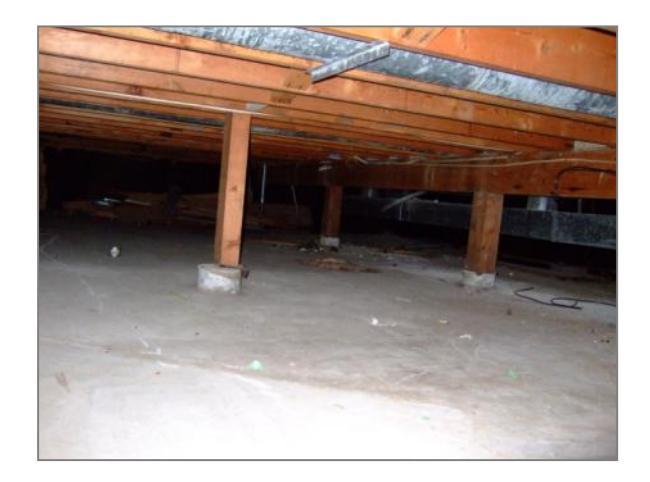
All homes in the Evergreen, Beachwood, Davis Hill and New Hillside developments are built on uninsulated slabs. The homes in the historic Broadmoor development have uninsulated floors over unconditioned basements. There are ten homes in the new portion of the Broadmoor development with uninsulated floors over semi-conditioned and unvented crawl spaces. Floor assemblies in the Discovery Village/Miller Hill developments are located over ventilated crawlspaces and are insulated to R-30.

Figure 12. Foundation of newer (1960s) Broadmoor home

Since it is fairly cost prohibitive to insulate on-grade slabs post construction, there is no recommendation to insulate homes built on slabs at this time. Where floors are built over unconditioned basements or crawl spaces, there are opportunities to add floor insulation. The older Broadmoor homes are built over unconditioned basements and would benefit from floor insulation. However, the floor above the basement is unconventional (joists over concrete) and may prove very difficult to insulate effectively without significant damage to recently refinished hardwood floors. The 10 homes in Broadmoor that were built in the 1960s could be air sealed at the floor and insulated to R-30. If the floor is insulated, the crawlspace would need to be ventilated to code requirements. Another option is to air seal and insulate the rim joist and stem wall to current code specifications. In either case, a vapor barrier should be installed to cover the crawlspace slab.

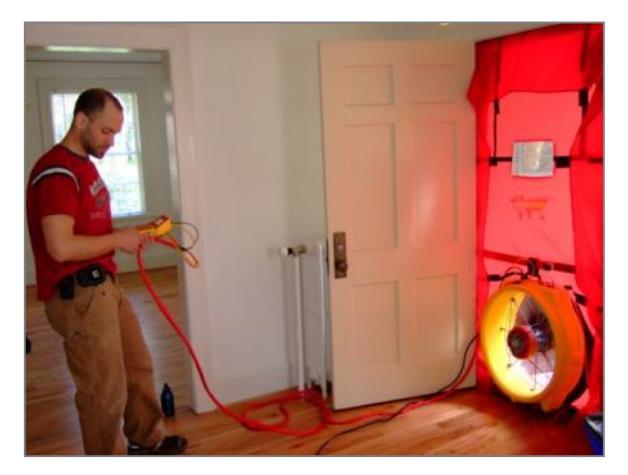
Leakage rates for the Discovery Village/Miller Hill development averaged 4.14 ACH₅₀ (17 homes tested). These rates are well below the ENERGY STAR target leakage of 7.0 ACH₅₀.

Figure 14a. Blower door testing

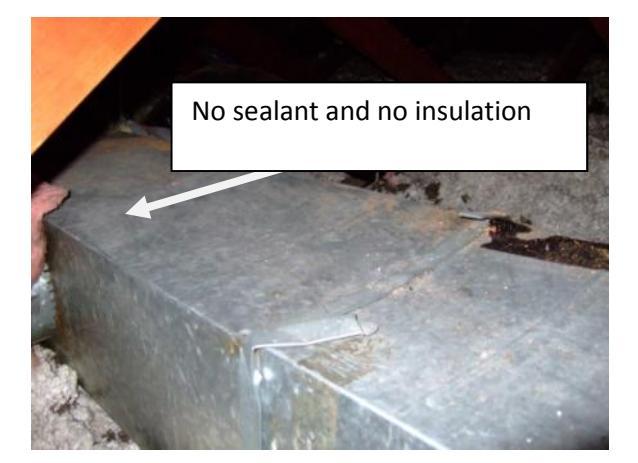
Homes at Evergreen, Beachwood, Davis Hill and New Hillside had supply ducts installed in the unconditioned attic space. Supply plenums were uninsulated and unsealed metal with insulated flex duct attached to supply plenums with varying degrees of sealing and mechanical fastening. Return duct work was typically a through wall plenum or flex jumper type duct into the mechanical closet from a hall way. Returns were uninsulated with varying degrees of air sealing.

Figure 15a. Typical duct system

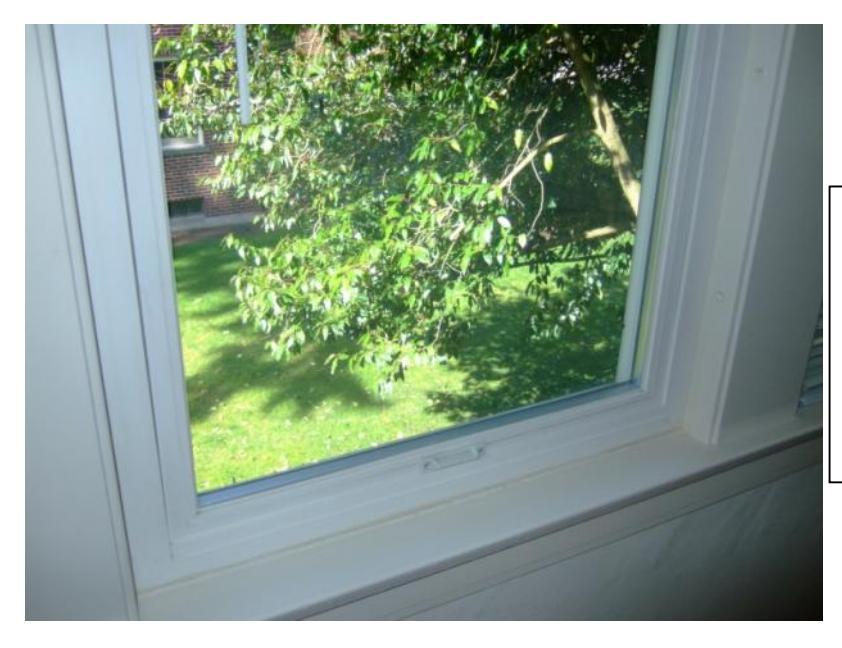
New vinyl Non-historic addition had been retrofitted with thermally efficient double- glazed vinyl windows in non-historic addition (sun porch)

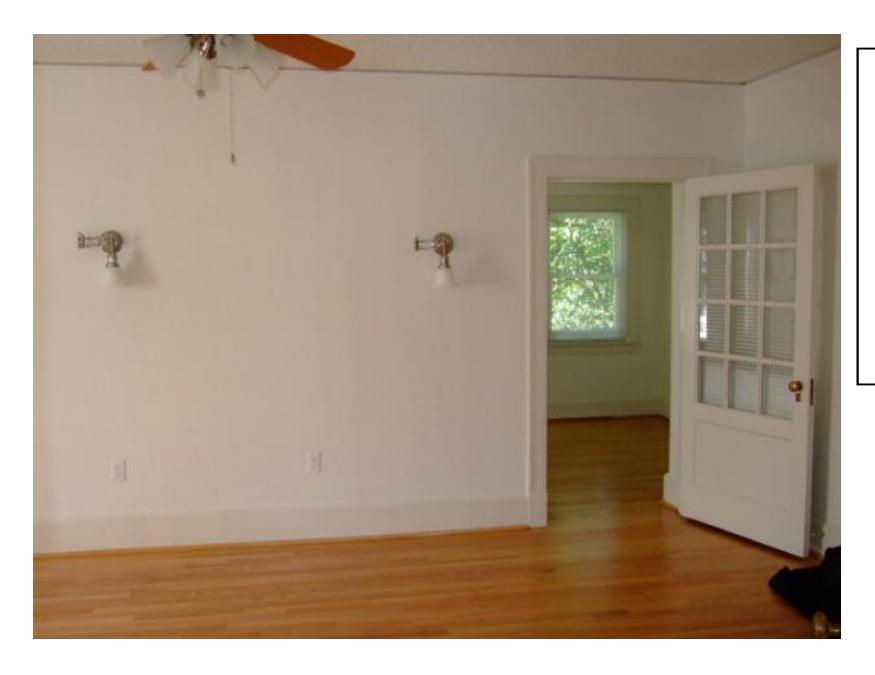
- View through doorway leading to "sun porch" addition to conditioned space.
- Period appropriate lighting fixtures may inhibit use of high efficiency lamps.

Although these homes are of historical significance and alteration of exterior facades may be regulated by federal guidelines, interior alterations are rarely regulated. Therefore, replacement of all incandescent lighting with high efficiency lighting is recommended. The lighting load for this home can be cut by at least half by switching out each lamp with a compact fluorescent lamp (CFL) without the need to change the fixtures or degrade the quality of light. A 2700K "warm white" CFL is recommended to match the light quality emitted by common incandescent lamps.

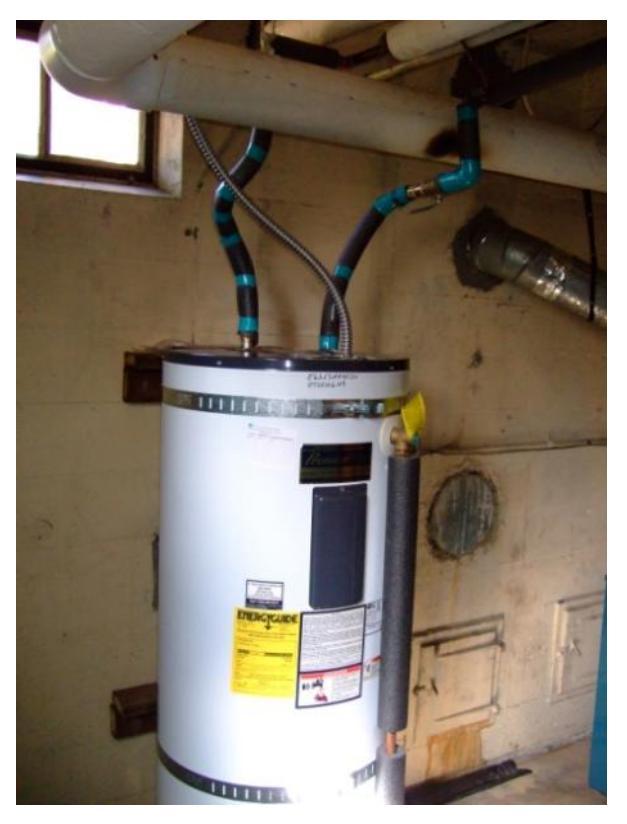
- Typical electric DHW, 0.91 EF
- Tanks sat directly on an unconditioned slab in an unconditioned basement.

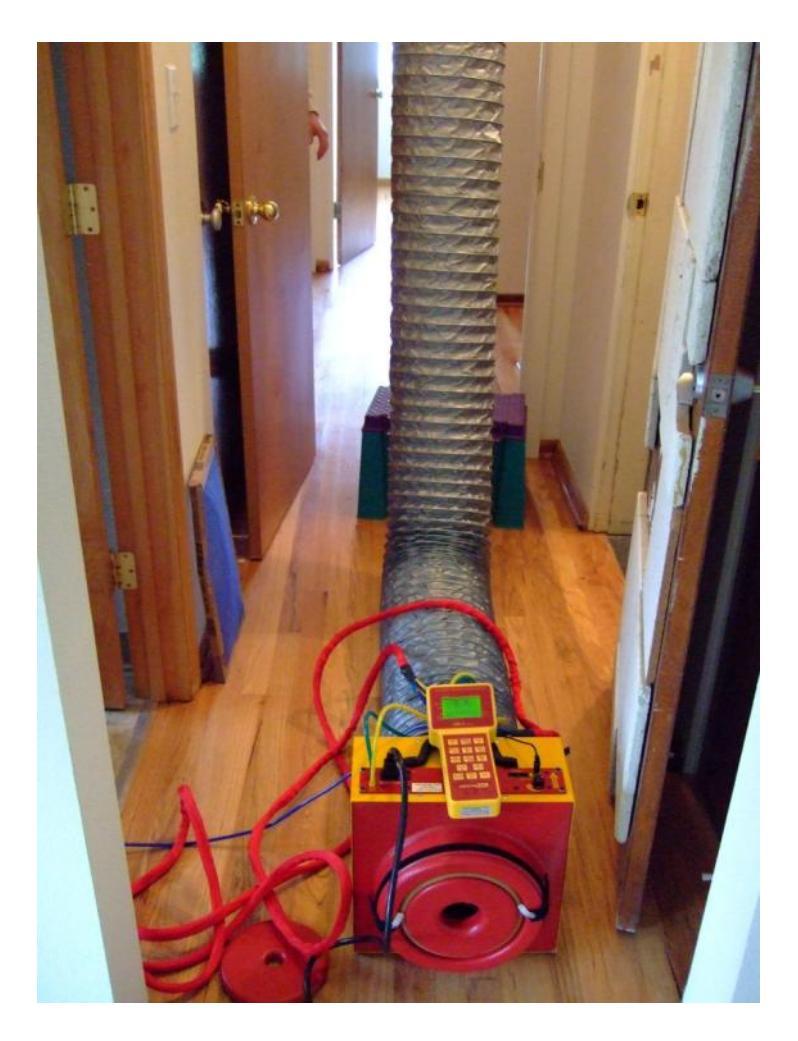
Duct tester connected to retrofitted return located in the hall ceiling outside the mechanical closet

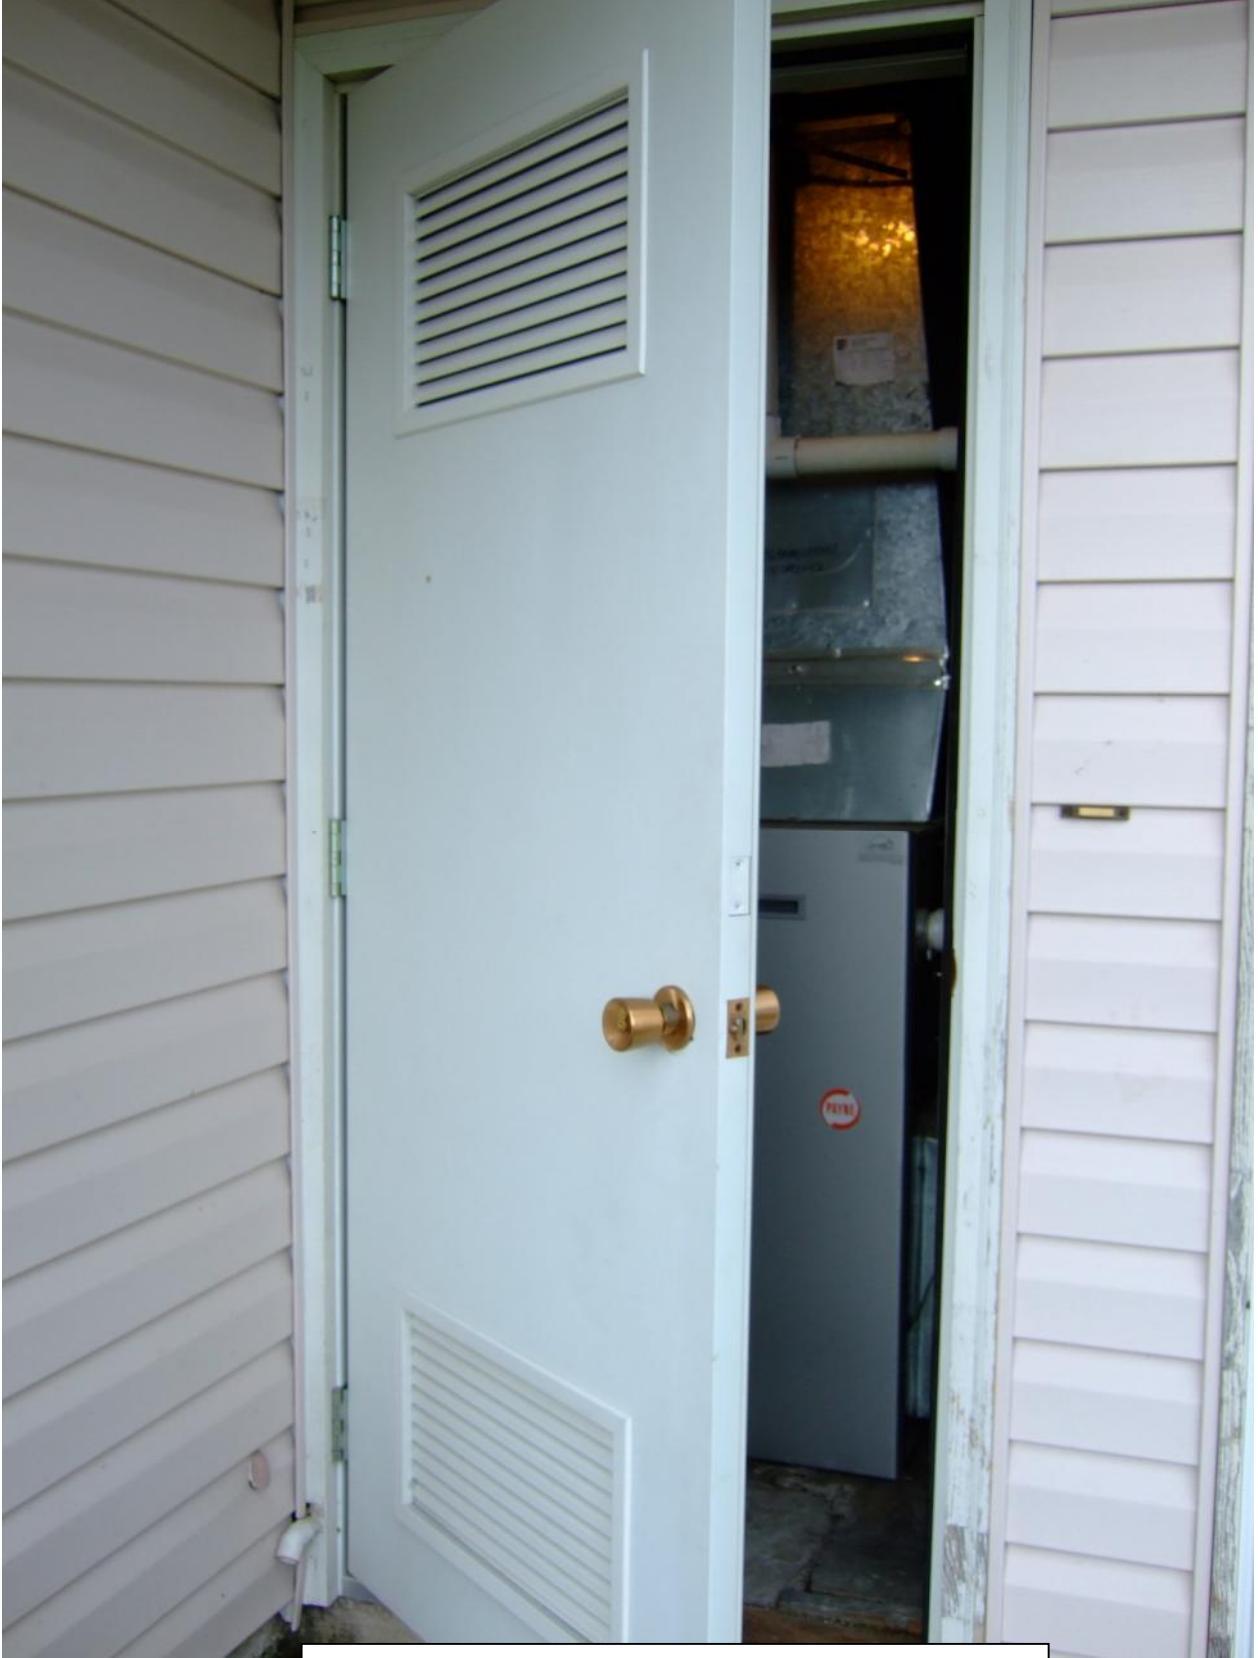
Exterior access unconditioned mechanical closet typical in Davis Hill and New Hillside developments

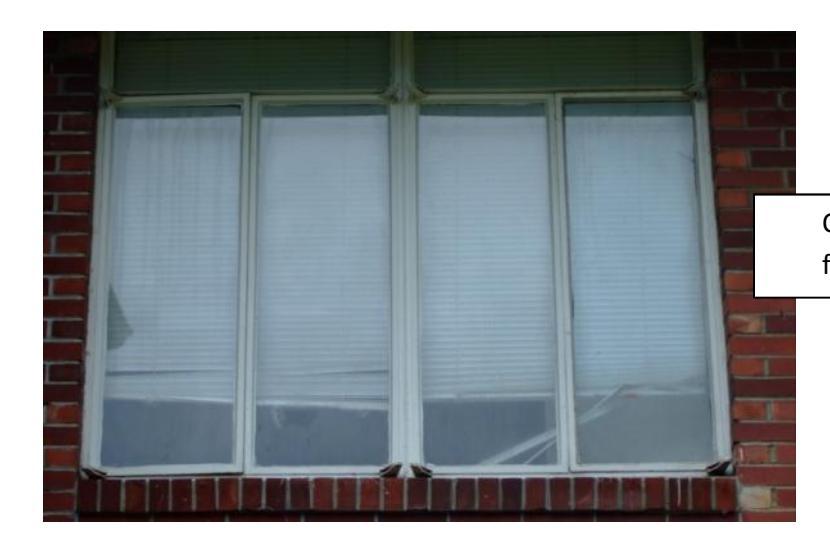
Original single-pane, metalframed casement windows

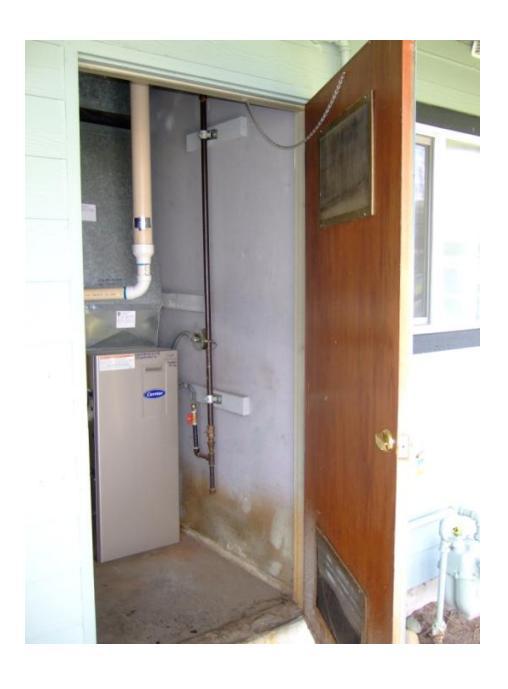
Typical furnace and DHW closet with exterior access. Note grills in door to provide combustion air to mechanical closet.
